SUCCESSFUL INSTALLATIONS IN SWEDEN WITH **NCC**

NCC Infrastructure, with its group HQ in Solna, Sweden recently completed two successful pipe rehabilitation jobs with their own, unique set of challenges.

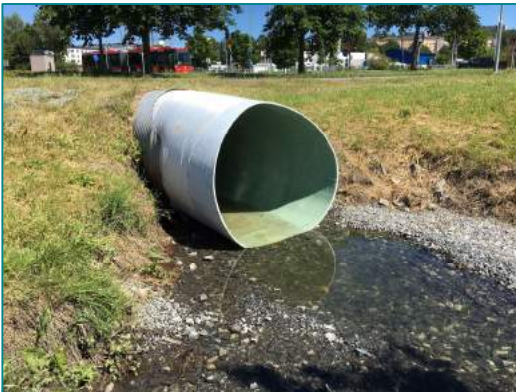
Successfully relined collapsing storm drain using DN 1400 underneath a park area in Järfälla, Stockholm.

One contract was in the Stockholm municipality of Järfälla .This involved the rehabilitation of a storm water pipe. The pipe was totally deteriorated through significant rusting and was close to collapse.

The pipe in lay under a park area and continued under a road carrying heavy volumes of traffic.

Rehabilitation was required for 86 meters of the pipe length, and was successfully carried out using the Berolina Liner DN 1400 - a total of 9,500kg's of liner materials being used.

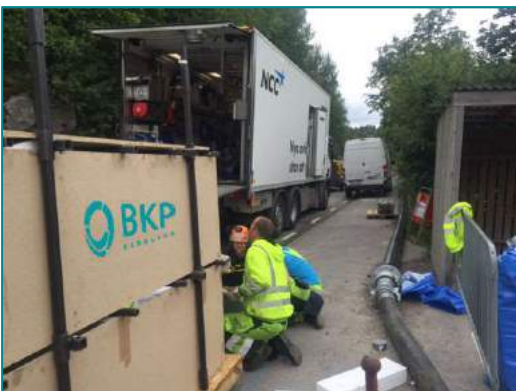
Installation using DN5 500 for 200 meter rehabilitation - Botkyrka, Stockholm.

The second installation was in the Botkyrka municipality, southeast of Stockholm.

The rehabilitation was for a pipe length of 200 meters using DN 500, and was also in an area with heavy traffic.

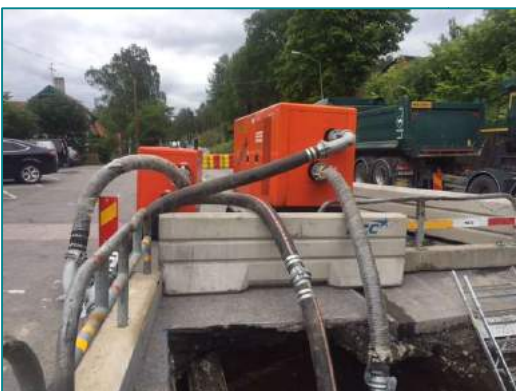
A complex pumping setup was required to enable successful installation of the liners.

A complicated pumping structure was necessary to prepare for and enable successful relining.
