**BKP Berolina Polyester GmbH & Co. KG**

**Berolina-Liner System  
Lightspeed® in gravity pipe rehabilitation!**

# Berolina-Liner System

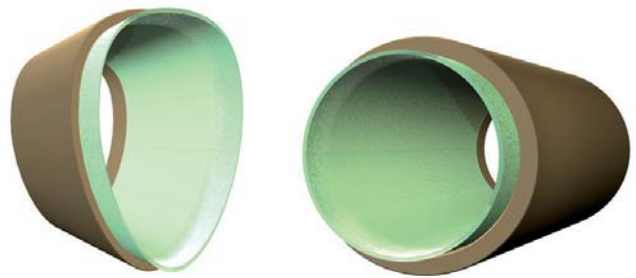
Tailor-made equipment variants make the application of the Berolina-Liner System possible at nearly any location globally

The Berolina-Liner System is completed by installation equipment specially optimized for the Berolina-Liner. This is offered by BKP in different adjusted variants according to clients' specifications.

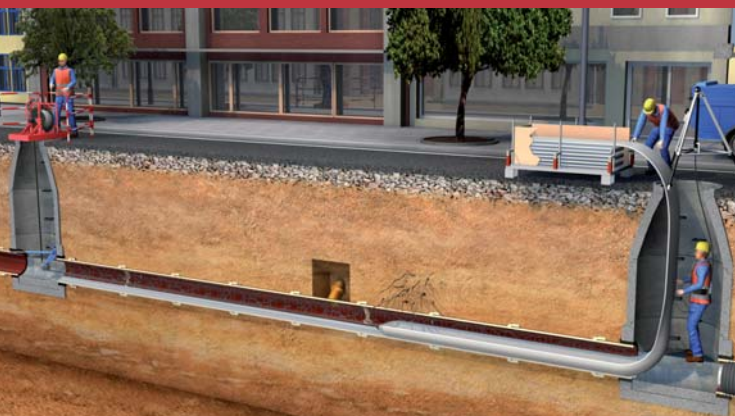
## Glimpses Into The Rehabilitation Process

After thorough cleaning, first the gliding foil and then the Berolina-Liner are winched in the host pipe. This procedure is known as the “winched in place procedure”. The two ends are closed with end cans, the tube carefully inflated with approx. 0.5 bar (7.5 psi) compressed air and pressed onto the pipe wall. In this way, the outer film of the Berolina-Liner prevents contamination from soil and ground water as well as penetration of resin into the laterals. The Berolina-Liner now adapts itself positively to all changes in the cross-section and profile.

Compressed air as a medium offers, among other things, the advantage that the uncured Berolina-Liner can be inspected during the drawing-in of the UV-light source with the help of a special camera. Following this, the UV-light source is ignited and drawn through the Berolina-Liner at a defined speed. The liner is thus cured through the UV-light.

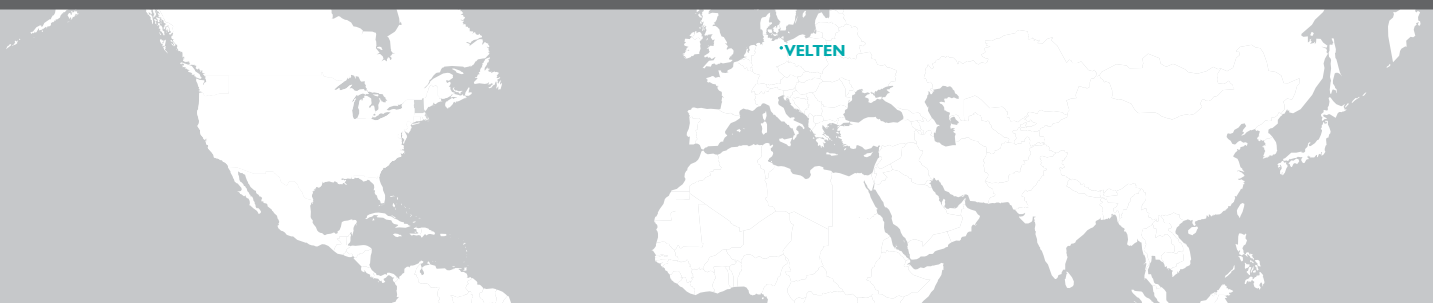
**For All Customary Pipe Profiles**

- Suitable for all circular and oval profiles, ID 150 mm - ID 1,600 mm (6" - 63") or other equivalent profiles
- Bridge-over of profile and cross-section exchanges is possible
- Highest mechanical parameters due to fiberglass reinforcement; for this reason, only slight wall thicknesses are necessary and there is only slight cross-section loss after the rehabilitation
- Selection of material according to requirements
- Reduction of waste products due to the curing procedure (e.g. no process water)
- Ordering according to stiffness classes
- Reduced energy requirements during production, transport and installation
- Complete opening of the laterals is possible immediately following the curing of the liner
