## **GRP Liner (CIPP) DN 1600 mm (63") successfully installed**

### ***Partial renovation of a rainwater culvert in Sweden using the Berolina-Liner***

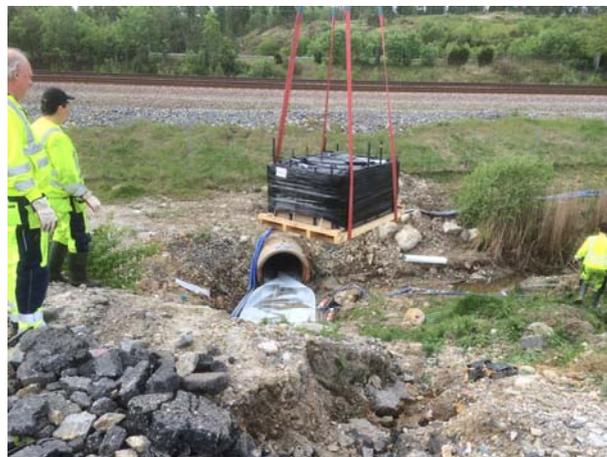
**The Berolina-Liner is located in front of the culvert**

A truck-mounted crane had to be used to position the almost 7 ton Berolina-Liner in front of the culvert. All installation equipment had to be lowered into the work area. The gliding foil and the Berolina-Liner could not be winched in as usual. Instead of a winch the crawler excavator had to winch in the Liner. One end can was connected and the liner was pulled in by moving the excavator forwards and backwards several times. Using this approach the Berolina-Liner could be pulled into the correct position of the culvert. The end can on the other outlet was then installed. The liner had been calibrated according to the manufacturer's

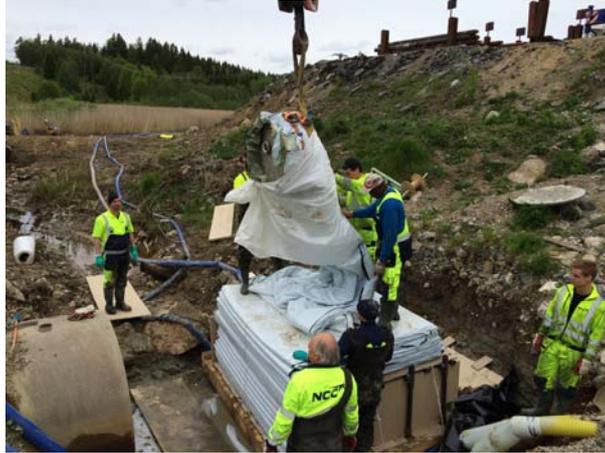
**The assembled end can was pulled together with the Liner**

specifications without any problems. The maximum internal pressure needed was 160 mbar (2,3 psi). This pressure calibrated the liner for a “close fit”, i.e. largely without any annular spaces, and even into the sectional corrugations adjacent to the existing pipe. The light train with 9 x 1000W lamps was pulled into the liner without any pressure loss by using an air lock. Once the liner had been completely cured by UV-light, the ends of the liner were cut off.

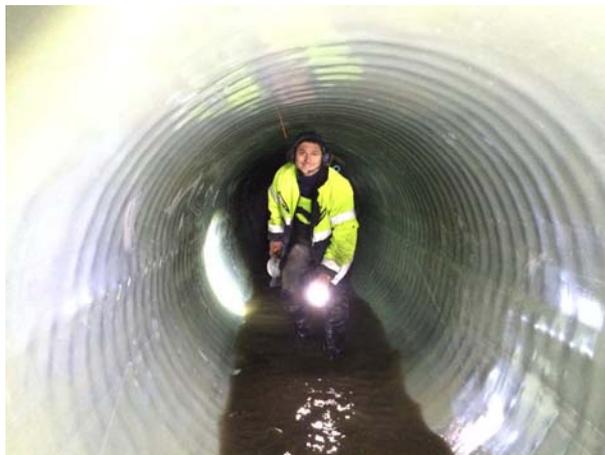
**Construction manager Magnus Eriksson (NCC) after the renovation in the Liner DN 1600 mm**
