The Berolina-Liner System

BKP Berolina Polyester GmbH & Co. KG

Lightspeed® in gravity pipe rehabilitation!

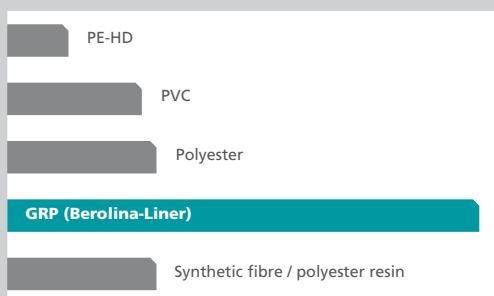
Ring E-module

The values of the Berolina-Liner, established by the "TÜV" (German Technical Monitoring Association) and the "Institute for Pipeline Construction at the Fachhochschule Oldenburg" (Technical College, registered association): stiffness SN 1,250 - SN 10,000, ring E-module at least 10,000 N/mm² (1,450,000 psi / 10,000 MPa), tension E-module approx. 14,000 N/mm² (2,030,500 psi / 14,000 MPa)

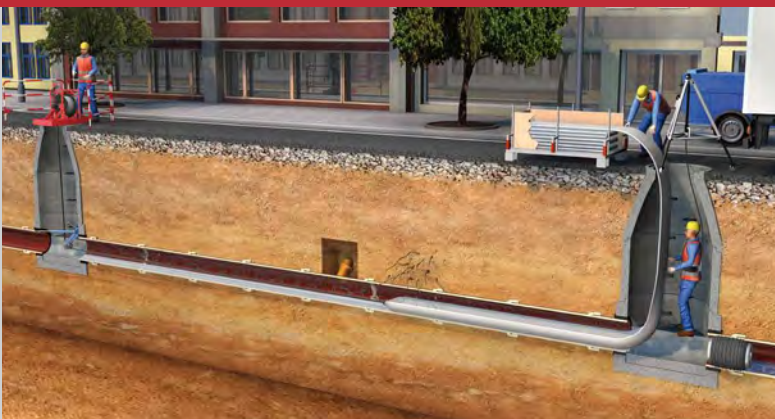
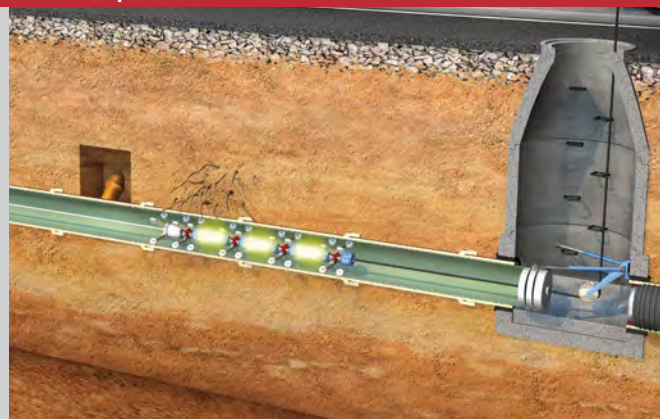
Glimpses Into The Rehabilitation Process

After thorough cleaning, first the gliding foil and then the Berolina-Liner are winched into the host pipe. This procedure is known as the “winched in place procedure”. The two ends are closed with end cans, the tube carefully inflated with approx. 0.5 bar (7.5 psi) compressed air and pressed onto the pipe wall. In this way, the outer film of the Berolina-Liner prevents contamination from soil and ground water as well as penetration of resin into the laterals. The Berolina-Liner now adapts itself positively to all changes in the cross-section and profile.

Compressed air as a medium offers, among other things, the advantage that the uncured Berolina-Liner can be inspected during the drawing-in of the UV-light source with the help of a special camera. Following this, the UV-light source is ignited and drawn through the Berolina-Liner at a defined speed. The liner is thus cured through the UV-light. The inner protective film is removed afterwards. The curing takes place emission-free with sealed-off tube endings. A new pipe is
